Final Report: An Investigation of Airtightness in Manitoba's Commercial Building Sector

Manitoba Hydro **Customer Engineering Services** Industrial and Commercial Solution Division

Applied Research and Commercialization Red River College of Applied Arts, Science and Technology and Proskiw Engineering Ltd.

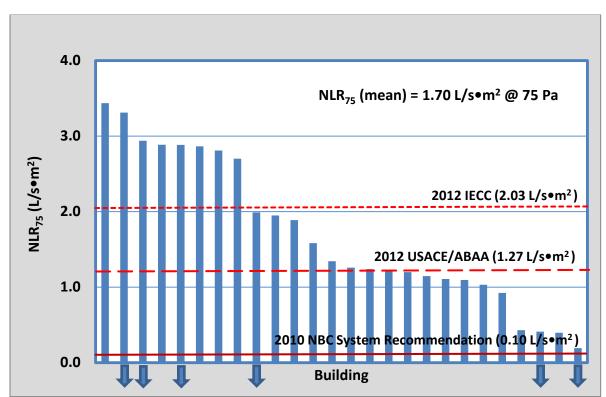
Figure 3 – Normalized Leakage Rate for Complete Sample of 26 Buildings Tested

The measured NLR₇₅ values ranged from 0.19 to 3.44 L/s•m², a variation of almost 18:1 between the leakiest and tightest buildings tested. The mean NLR₇₅ of the entire sample was 1.70 L/s•m², which is surprisingly similar to the mean value reported in the ASHRAE survey of new buildings (1.47 L/s•m²), even though most of the buildings in the ASHRAE study were designed and built to comply with some voluntary standard such as LEED. Only a handful of the buildings in the RRC study were designed and constructed with any explicit concern for airtightness.

Further, the Manitoba buildings tested for this project performed significantly better than those identified in the previous literature reviews by RDH or PEL.

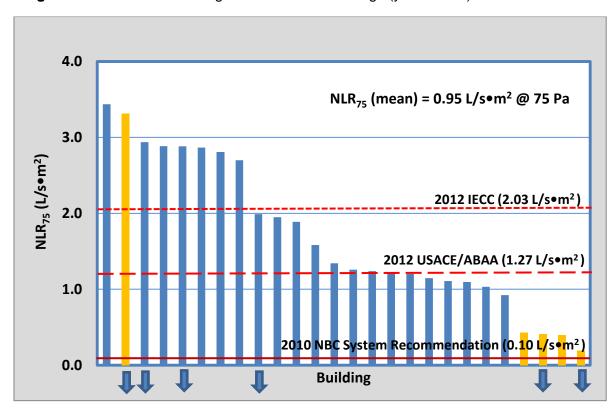
Figure 4 – Normalized Leakage Rate for New Buildings (yellow bars)

Examining the results, the airtightness of the five Manitoba buildings was surprisingly good. For example, the mean NLR₇₅ of the five Manitoba new-builds was only about two-thirds that measured during the recently completed ASHRAE project (which was restricted to new construction).

The Manitoba results become more impressive when it is recognized that 12 of the 16 buildings in the ASHRAE project participated in an environmental labelling program (such as LEED) in which deliberate efforts were often made to achieve a higher quality building envelope and tighter air barrier system. Also, the report's authors state that the "data set is biased towards tighter buildings due to self-selection and volunteerism by owners and architects". However, this must be tempered with the knowledge that all of the 16 buildings were constructed in the United States, which lags somewhat behind Canadian expertise in achieving airtightness in commercial construction.

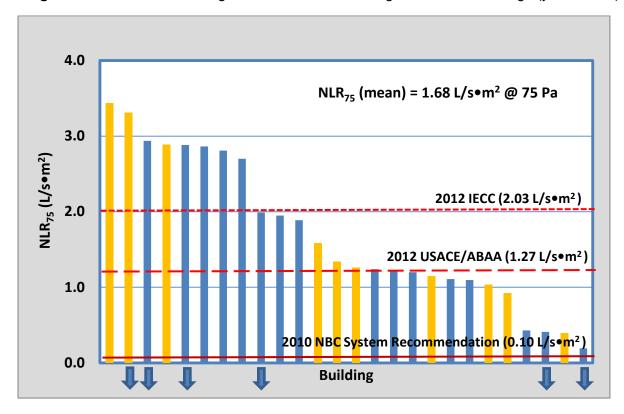
Figure 6 – Normalized Leakage Rate for Warehouse/Light Industrial Buildings (yellow bars)

Overall, the 11 warehouse-style and light industrial buildings in this large subset performed surprisingly well relative to those reported in the three comparative references. For example, the average NLR_{75} for these 11 buildings was only 14% greater than that of the 16 mostly new buildings in the ASHRAE sample.

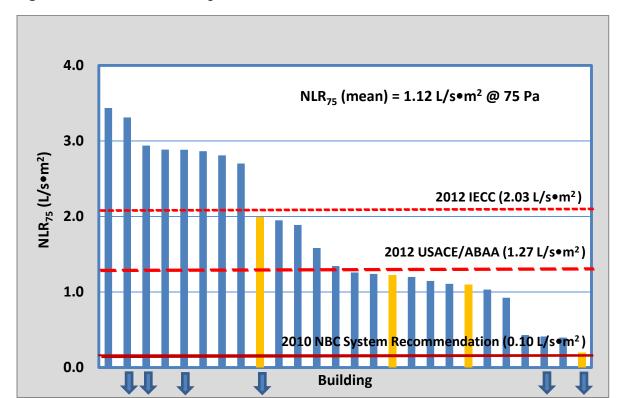
Figure 7 - Normalized Leakage Rate for Schools

Examining the ASHRAE data, the four Manitoba schools displayed an average NLR₇₅ which was lower than the average value reported in the ASHRAE study – even though all of the ASHRAE buildings were less than five years old and most had been explicitly designed to achieve a high level of airtightness. In contrast, the Manitoba schools had an average age of about 50 years and only one had been designed with any concern for airtightness.

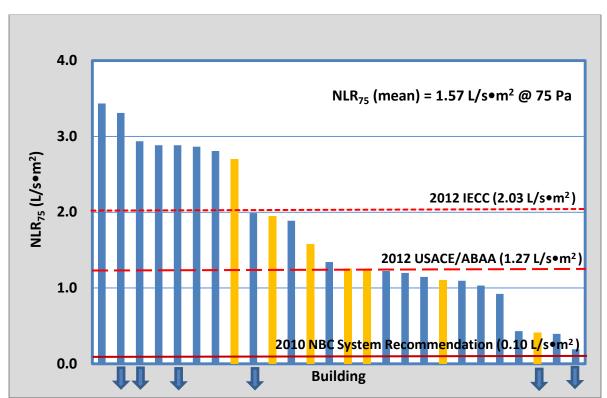
Figure 8 – Normalized Leakage Rate for Office Buildings (yellow bars)

The eight buildings referenced in the PEL report were all tested by NRC in the period 1971 to 1974 when the average age of the buildings was two years; all (or most) are believed to have been federal government buildings. Somewhat surprisingly, the average NLR₇₅ of the RRC sample was less than 2/3 of the NRC group. Although not shown in the table above, the PEL report also referenced a sample of 12 British office buildings which displayed a mean NLR₇₅ of 7.55 L/s•m². This is dramatically higher than any of the Canadian results and most likely reflects both the age of the buildings and the fact that airtightness was not perceived as a building science or design issue when they were constructed.

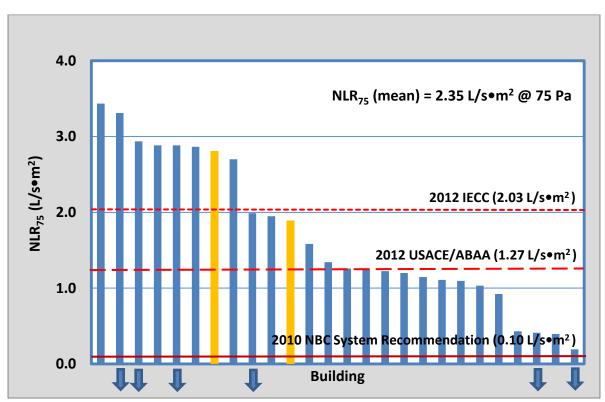
Figure 9 – Normalized Leakage Rate for Churches (yellow bars)

As a sample sub-group, the two churches were comparatively leaky with only greenhouses displaying a higher mean NLR₇₅ value. For example, the mean NLR₇₅ of the two buildings tested was about 60% higher than the corresponding NLR₇₅ in the ASHRAE study. Given the age of the buildings and the fact that the sample size was only two buildings, it is unclear how representative the results are of typical church buildings.

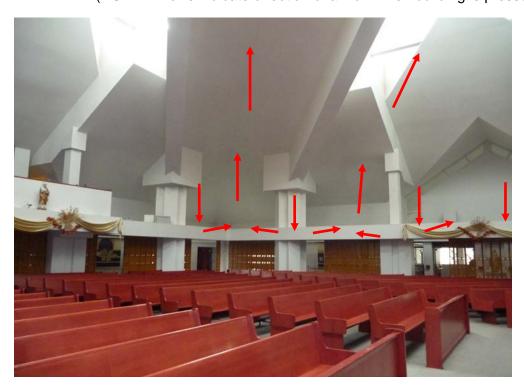
The second building also had a large chapel area with a vented attic space at the top. It employed a rather unique design in that that the chapel roof was structurally supported by tilted, steel components which formed the framework for the roof. Since the steelwork was located inside the building, it was covered by a series of drywall bulkheads which formed enclosures that ran to the apex of the roof (see Figs. 9 and 10 below). Lower down, the bulkheads ran into a

Figure 10 – Roof Structure Supported by Bulkheads that Connect to Perimeter Ring (NOTE: Arrows indicate direction of airflow when building is pressurized)

After considerable investigation, it was discovered that the bulkheads opened into the attic space, thereby creating a series of massive air leakage channels, and also opened into the bulkhead ring surrounding the chapel. Further, the top of the bulkhead ring was anything but airtight, with many large areas completely open to the chapel space. Since the top of the ring bulkhead was not visible from ground level, there was little indication that this was a problem. Basically, air was able to leak from the chapel space, into the top of the ring bulkhead, flow horizontally to one of the sloped bulkheads which it entered and then flowed vertically into the vented attic space. Not only was this a very unique construction detail (and air leakage path), but it was also one that was very difficult to identify. Interestingly enough, the authors have subsequently encountered a very similar detail on another building (not part of this study) which caused significant moisture damage to the structure resulting in repairs costing several hundreds of thousands of dollars.

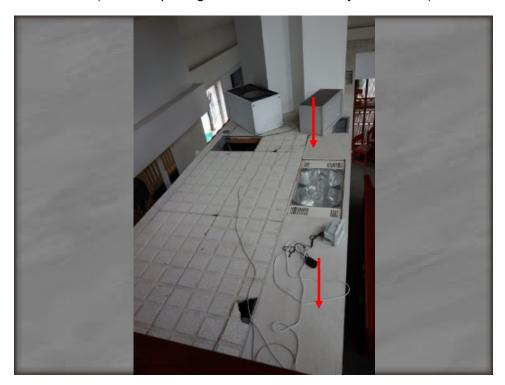
Figure 11 – Top of Perimeter Ring Open to Interior Space (NOTE: Openings as found indicated by red arrows)

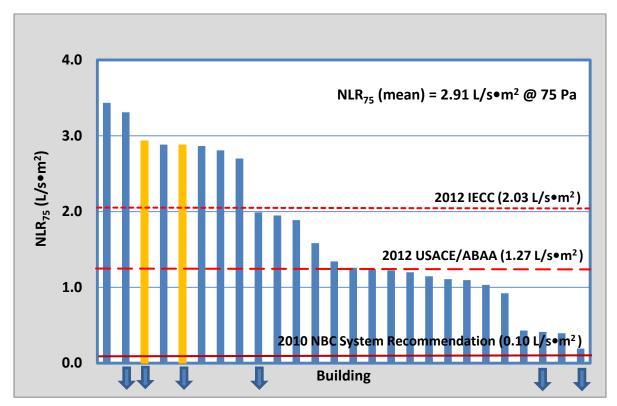
Figure 12 – Normalized Leakage Rate for Greenhouses (yellow bars)

One point to note is that these two buildings were tested under depressurization mode only, no pressurization tests were performed.

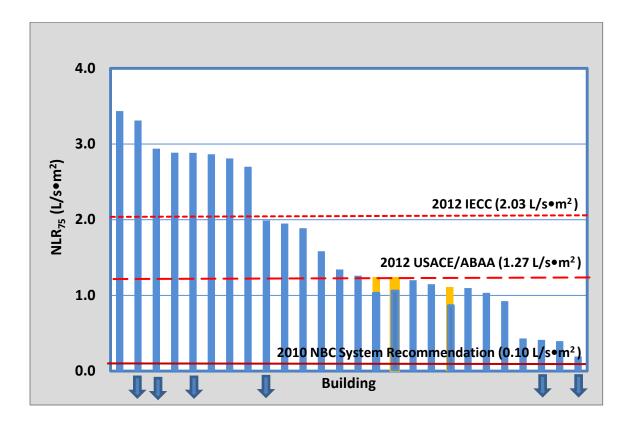
Building	NLR ₇₅ (NLR ₇₅ (L/s•m²)		Percentage
Building	Pre-Retrofit	Post-Retrofit	Reduction	Reduction
#3	1.24	1.03	0.21	17%
#4	1.11	0.90	0.21	19%
#11	1.22	1.06	0.16	13%

Figure 13 – Impact of Air Leakage Sealing / Building Envelope Retrofits (Yellow bars indicate pre-retrofit NLR₇₅, Blue bars indicate post-retrofit NLR₇₅)

The project also studied the impact of air leakage sealing on three of the 26 buildings which were, or had been, recently retrofitted (two offices and one school). These retrofits produced absolute reductions in the NLR_{75} which were surprisingly consistent, ranging from 0.16 L/s·m² to 0.21 L/s·m². This represented an average reduction of 16% in the NLR_{75} . Interestingly, the two buildings that had all or most of their glazing replaced experienced the same reduction in their NLR_{75} - 0.21 L/s·m².
