EVALUATION OF THE WINTER PERFORMANCE OF COMPRESSED NATURAL GAS REFUSE TRUCKS

NOVEMBER 15, 2013

**ECOTECHNOLOGY FOR VEHICLES PROGRAM
STEWARDSHIP AND SUSTAINABLE TRANSPORTATION
TRANSPORT CANADA**

**DR. ALEX LAWSON, ALEX LAWSON ASSOCIATES INC.
NEIL COOKE, RED RIVER COLLEGE**

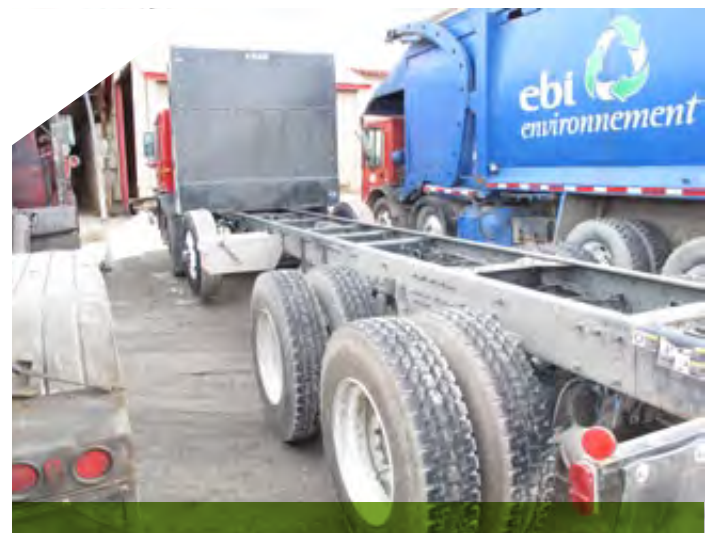
Figure 2 - Incomplete & Complete EBI Refuse Trucks

Before new refuse trucks are delivered to EBI, the Peterbilt chassis shown on the left below, is delivered to the Labrie facility located near Montreal where the refuse body and CNG fuel storage system are installed as part of the final stage of manufacturing.

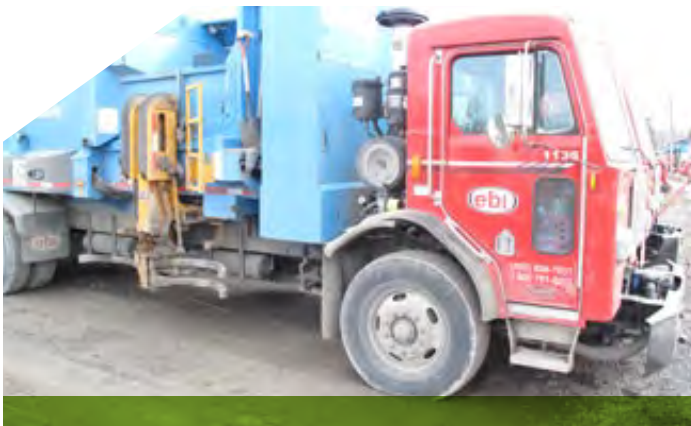
Figure 3 - EBI CNG Refuse Truck

The CNG fuel storage system consists of five Dynetek Type 3 carbon fibre-wrapped aluminum fuel storage tanks with a storage capacity of 82 diesel gallon equivalent (DGE) located in an enclosure behind the cab as shown in the picture below. The tank enclosure adds an estimated 20" to the truck length and is mounted on the frame rails. This CNG tank package adds approximately 800 kg of weight which includes the tanks, instrumentation, and the back of cab enclosure. The CNG tanks are designed to be able to store natural gas at 3,600 psi. Private fleets with their own CNG refueling stations can fill to 3,600 psi in Canada. Vehicles that access public stations are currently limited to 3,000 psi pressure in Canada, although there is a proposal to change the current code (CSA B108-99) to allow 3,600 psi refueling at all CNG refuelling stations in Canada. In the U.S., all CNG refueling stations fill to 3,600 psi.

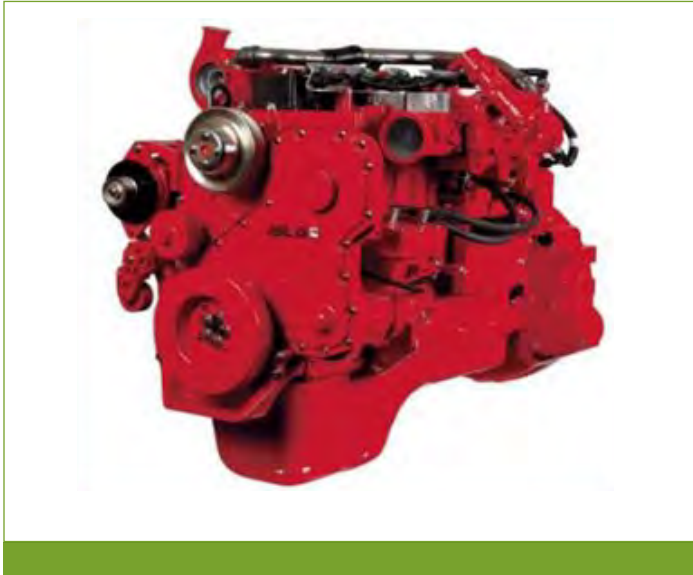
Figure 6 - Cummins Westport ISL G Engine

The Cummins Westport ISL G engine is integrated by all truck manufacturers who offer natural gas chassis suitable for refuse applications. This 8.9 litre spark-ignited, 320 HP 1000 lb.ft torque at 1,300 rpm stoichiometric engine uses a three-way catalyst and does not require the use of a diesel particulate filter to reduce particulate matter (PM) emissions or a selective catalytic reduction (SCR) system to reduce NOx emissions.

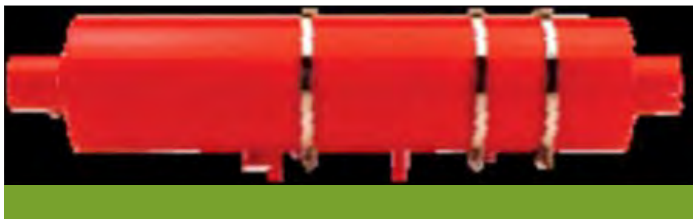
Figure 7 - Cummins Westport Three-Way Catalyst

The technology also uses cooled exhaust gas recirculation (EGR) which results in 30% better torque at idle and 5% better fuel economy compared with previous generation lean burn CNG technology. Cooled EGR replaces the additional air in lean burn technology, reduces combustion temperatures similar to lean burn engines, and offers better efficiency and power density compared with lean burn and conventional stoichiometric engines.

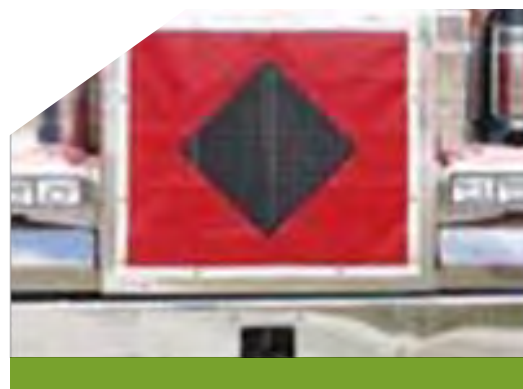
Figure 9 - Typical Winter Front

Air flow across the engine can extend warm up time and, in very cold weather, prevent the engine from reaching minimum operating temperatures. This can be corrected by adding electrical coolant heaters to maintain coolant temperatures overnight and to aid in bringing the coolant to the minimum operating temperature required for start up. For colder temperatures, radiator shutters or "winter fronts" as they are also known, should be installed. A typical winter front is shown below.

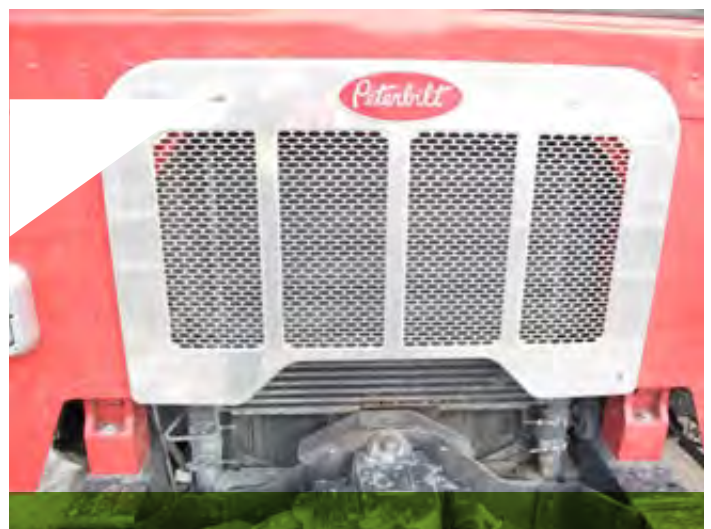
Figure 10 - Conventional Radiator Design

Being a conventional cab over design, with the radiator located under the cab, the engine compartment is enclosed allowing heat build-up from the engine. Data logger information has shown that coolant temperatures of 80 C can be maintained in an ambient temperature of -16 C during the stop and go duty cycle of the refuse trucks. The starting aids deemed necessary were therefore coolant and oil pan heaters to assist starting.

As seen in the picture on the previous page, there are no radiator winter fronts on the vehicles, but the radiator is well protected within the engine compartment based on the design of the vehicle.

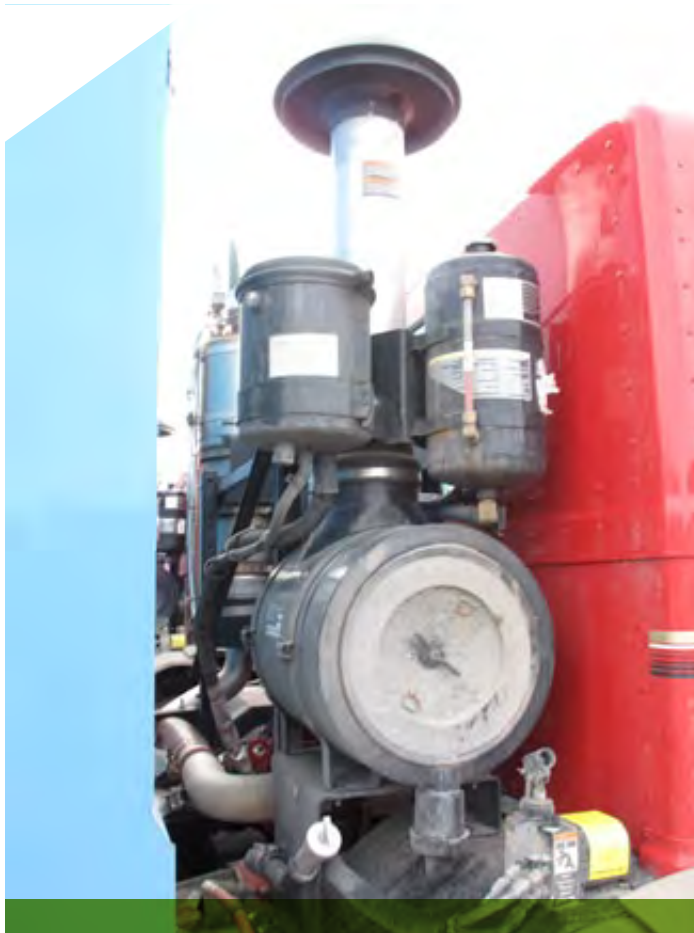
Figure 11 - EBI Conventional Air Intake System

The EBI intake air system shown below is conventional without special winter aids.

There is no ducting routed from the engine compartment to the air cleaner inlet, but there is good protection from the elements behind the cab and close to the exhaust system.

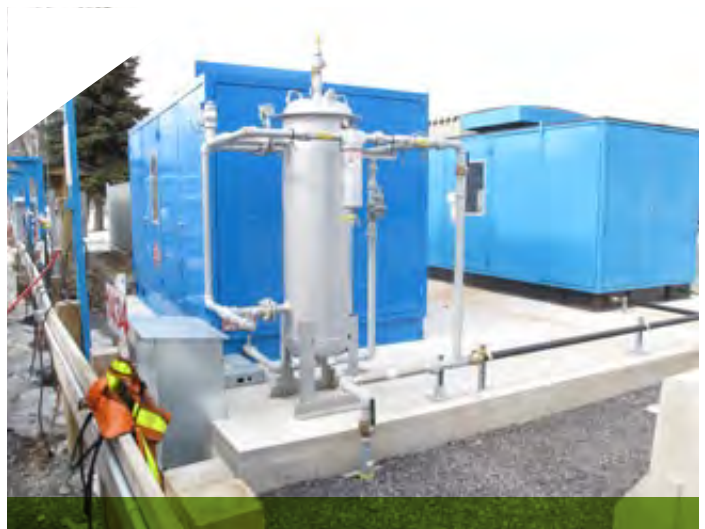
Figure 12 - Sulzer Compressor Station

The refueling needs of the EBI fleet are met with the use of a “Sulzer” natural gas compressor that has been installed and maintained by Syst Mes GNC Inc. of Laval, Que. There are two model C50 2-11 GPX Sulzer units on site with one of the units put into service six months ago to replace an original trial unit with a second unit of the same size and design. These compressors meet the needs of both the time fill overnight refueling system as well as that of the fast fill dispenser also located on site. These two dispensing systems allow for the units to time fill, but if fuel demands are higher than expected throughout the normal operational hours, fast fill capability is available. Both systems use the industry standard NGV 3.1 compliant nozzles for vehicle refueling and were designed to meet the CSA B108 standard for CNG refueling stations.

The Sulzer compressor station has a system capacity of 172 standard cubic feet per minute (SCFM) @ 200C and has a 25 pounds per square inch gauge (psig) limit on the inlet side of the system. The 25 psig limit on the intake is considered to be slightly above expected available pressures during the winter months due to higher demand for natural gas for winter heating from the local gas distribution system. Some system designers have stated that inlet pressures within the winter months may be closer to 20 psig in this local area. Local gas distribution companies can advise regarding typical system pressures at different times of the year.

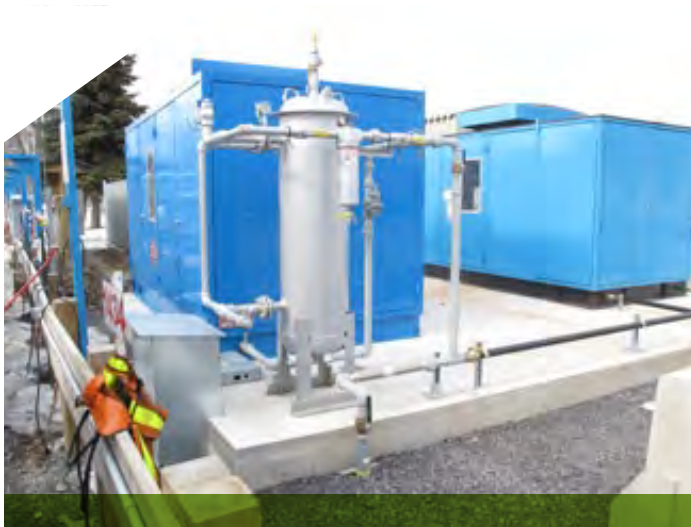
Figure 13 - PSB Natural Gas Dryer

The dryer selected for the station is a PSB model NG-SV-5.0-1.5 unit. This is a “suction side” dryer that is more economical than installing a high pressure discharge dryer. Some design companies prefer the high pressure discharge units as they are seen as a system that limits moisture within the system versus the suction side systems which require replaceable desiccant.

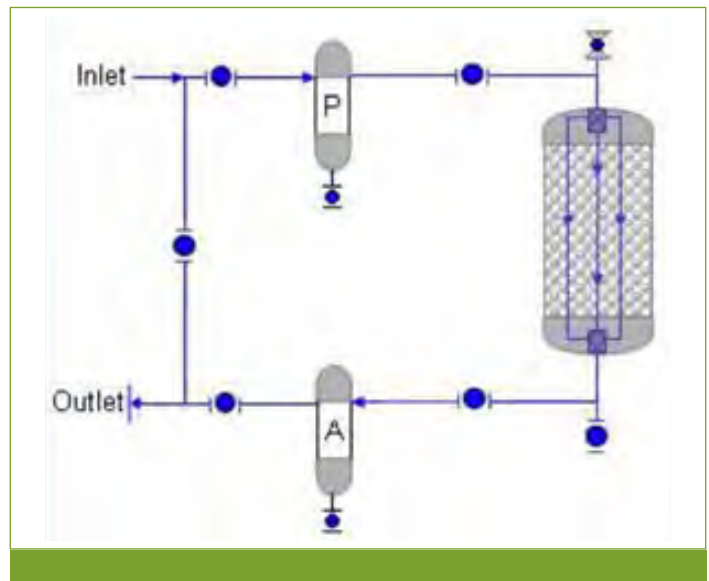
Figure 14 - Gas Dryer Schematic

Typical flow through the dryer system is a closed loop system with a heat exchange system built into the unit to remove moisture generated through compression of the gas. It was not mentioned throughout the interview with the Fleet Manager whether normal desiccant was used in the dryer or whether an alternative type of “super” desiccant is used.

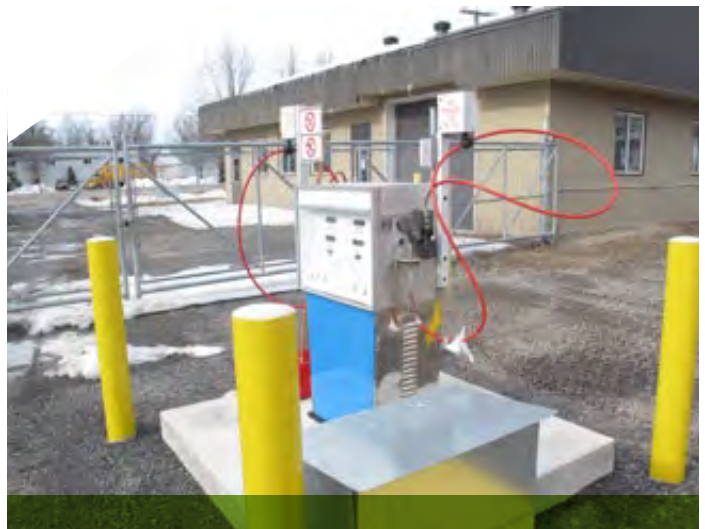
Figure 17 - Fast Fill Dispenser

A fast fill refueling pump is located on a separate small island for periodic fast fill of CNG service vehicles.

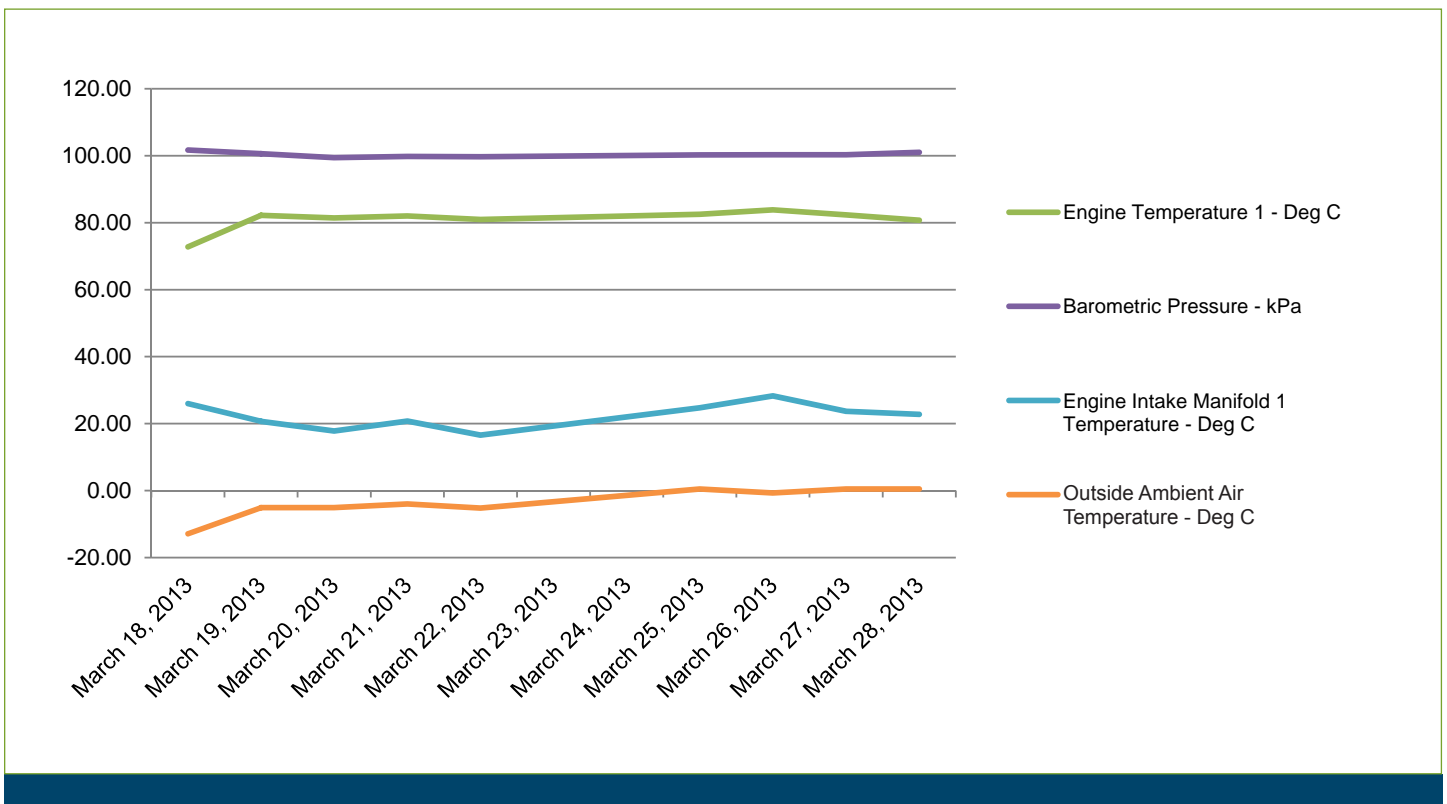
Graph 3 - Unit 1875

With the widest selection of data incorporated into the table and graph below, the next two figures again highlight the thermal effectiveness of the CNG engine in this specific vehicle

configuration. The engine consistently operates within specified limits for coolant temperature operating levels and exhibited no reliability issues during the timeframe of data collection.

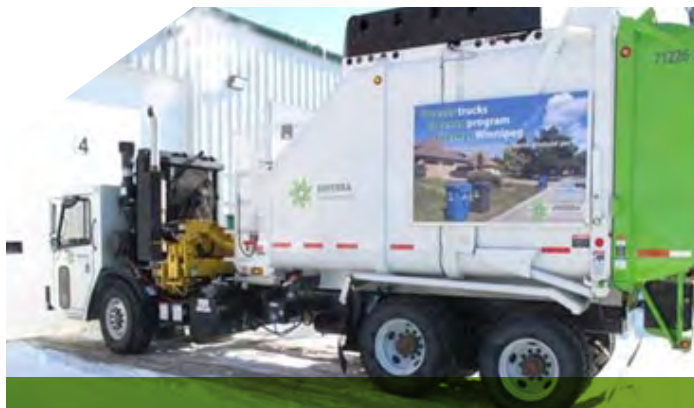
Figure 22 - Emterra Low Entry Refuse Truck

Emterra's trucks are equipped with the Cummins Westport 8.9L, ISL G engine. The CNG engines are installed into a CCC Low Entry Tilt model LET2 chassis. The chassis is fitted out with either a Heil Durapak rear loading collection body or the Heil Rapid Rail automated side loading body.

The bodies provide the platform for the top mount CNG multi tank storage system which adds height to the vehicle, but does not require the use of a longer frame as with back of cab CNG tank systems.

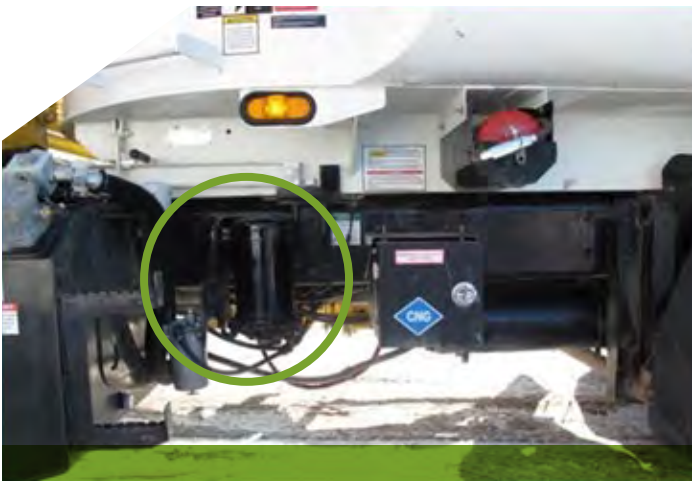
Figure 23 - Fuel Filter on Emterra Truck

The fuel filter is located in a convenient location for draining compressor oil, but is relatively open to the ambient weather. A secondary filter is located under the exhaust system.

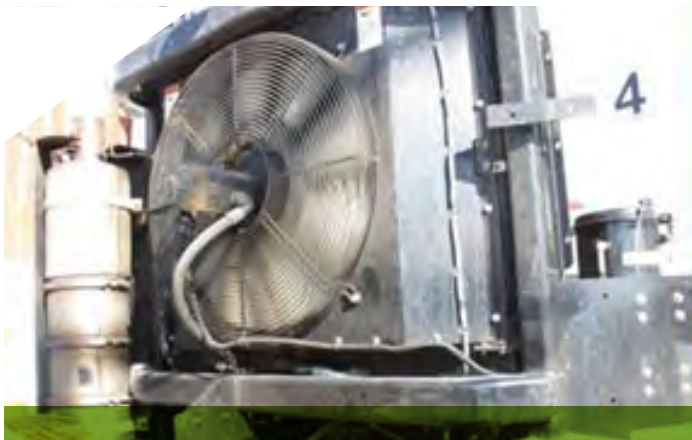
Figure 25 - Behind Cab Radiator Cooling System

This particular chassis also incorporates a behind the cab radiator cooling system that is constructed with a 1200 sq.in. surface area with a triple core design. A hydraulically-driven fan assembly provides supplementary cooling effect if necessary.

The radiator cooling system is located behind the cab in the Emterra trucks, and so it is not within the confines of the engine compartment where it would be exposed to heat build-up in the compartment from the engine operation. It appears that the arctic temperatures experienced did not allow the engine coolant to reach the required operating temperatures with this vehicle design in the absence of winter aids. Issues such as ice build-up in the air intake were related to the engine operating below its designed temperature of about 80 C , and an inability to maintain the inlet air temperature above 0 C .

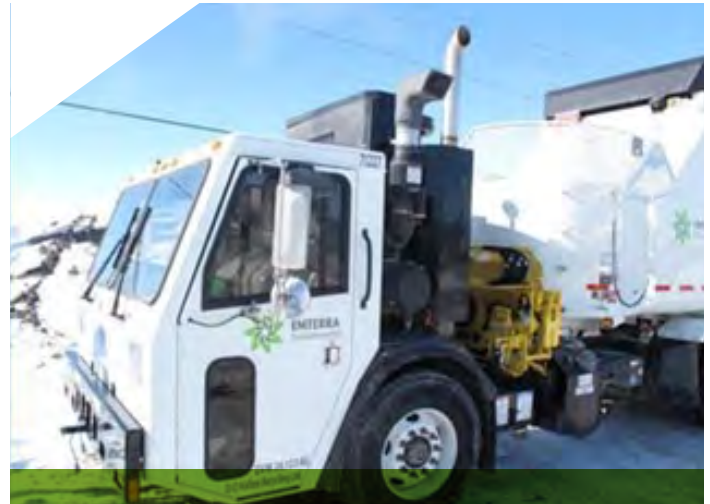
Figure 26 - Air Intake Plenum

The Emterra vehicles have a standard dry air filtration system with a ram air intake plenum that extends above the rear left hand side of the cab.

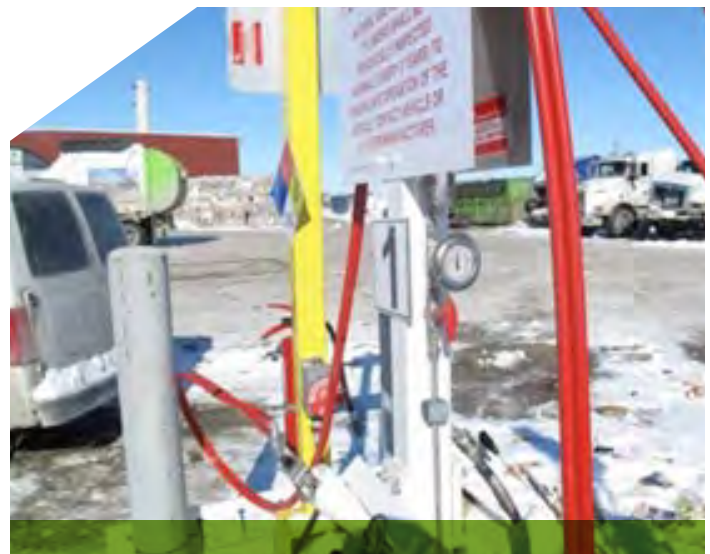
Figure 27 - Fill Post with Pressure Gauge

Truck refueling is accomplished via a bumper mount refueling connection that is compliant with the ANSI NGV 3.1 standards. The refueling station used to refuel the trucks is a time fill system that also has the capabilities to rapid fill if necessary.

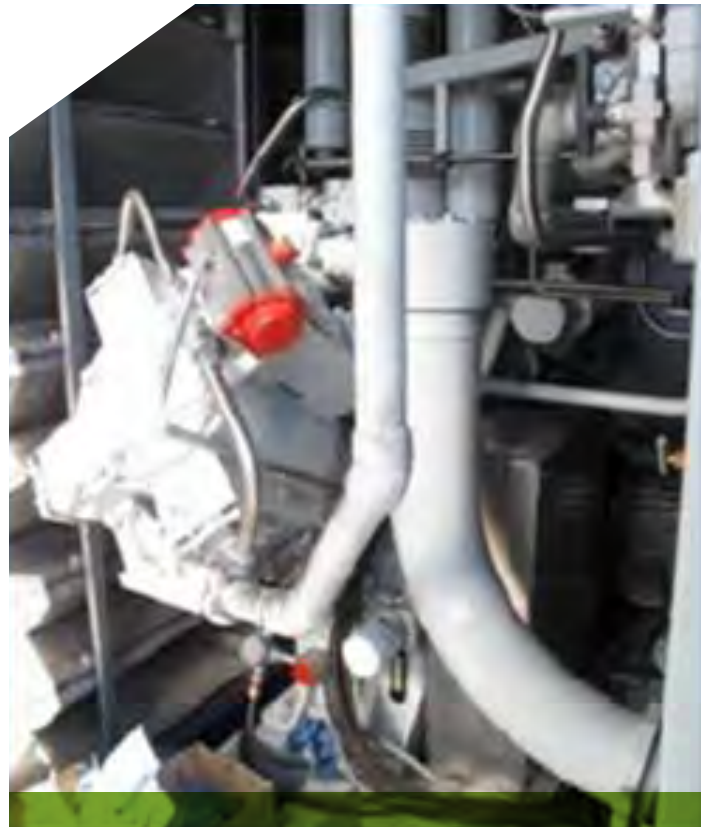
Figure 30 - Equipment Inside Enclosure

The refueling needs of the fleet are met via a Clean Energy CNG refueling station. The station utilizes a multi-stage compressor that has the maximum capability to operate at 1,000 SCFM. The maximum inlet pressure of this system is 25 psig, but normal operating conditions at this station are at a constant 20 psig. The compressor station is also equipped with a high side suction dryer to ensure that the fuel supply is dried for use in CNG-equipped vehicles.

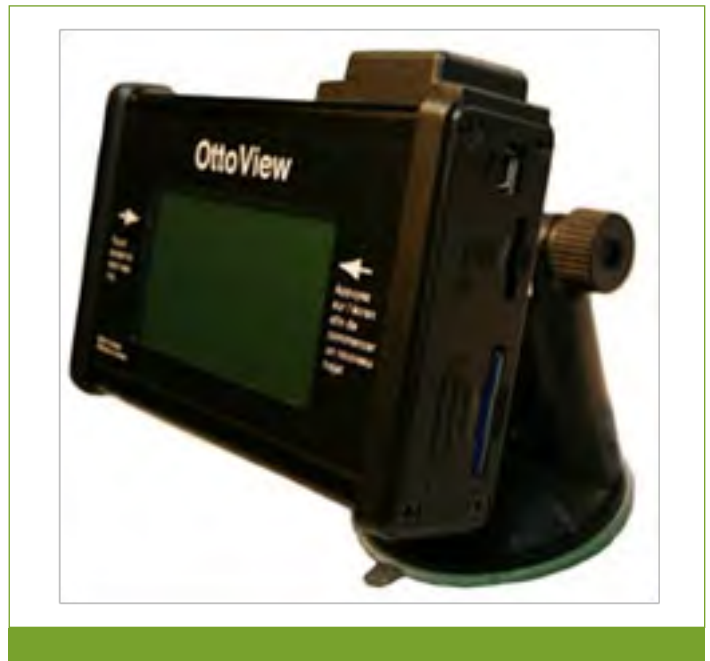
OttoView-CV242

The device is powered entirely through the vehicle's OBDII connector and will operate over a voltage range of +9VDC to +12 VDC. The device will turn-off (sleep mode) approximately 60 seconds after the vehicle is turned off, thereby not imposing any load on the vehicle's battery and electrical system. The device interrogates the ECM for data and does not modify/change any vehicle parameters.

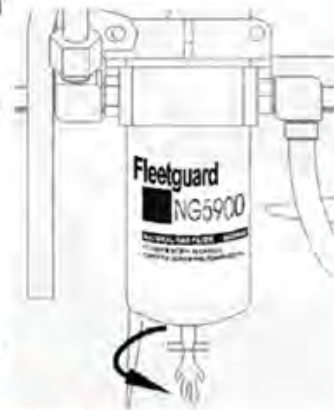
Fuel Filter (Spin-on Type) - Drain

- Shut off the engine. Use your hand to open the drain valve. Turn the valve **counterclockwise** approximately 1-1/2 to 2 turns until draining occurs.
- Drain the oil from the fuel filter.
- When closing the drain valve, do **not** over tighten the valve. Over tightening can damage the threads. Turn the valve **clockwise** to close the drain valve.

- **no more than one ounce of oil in the fuel filter.**
