Airtightness in Existing Multi-Unit Residential Buildings: Field Trials of a New Test Protocol

Red River College
Applied Research and Commercialization
Sustainable Infrastructure Technology Research Group
August 28, 2015

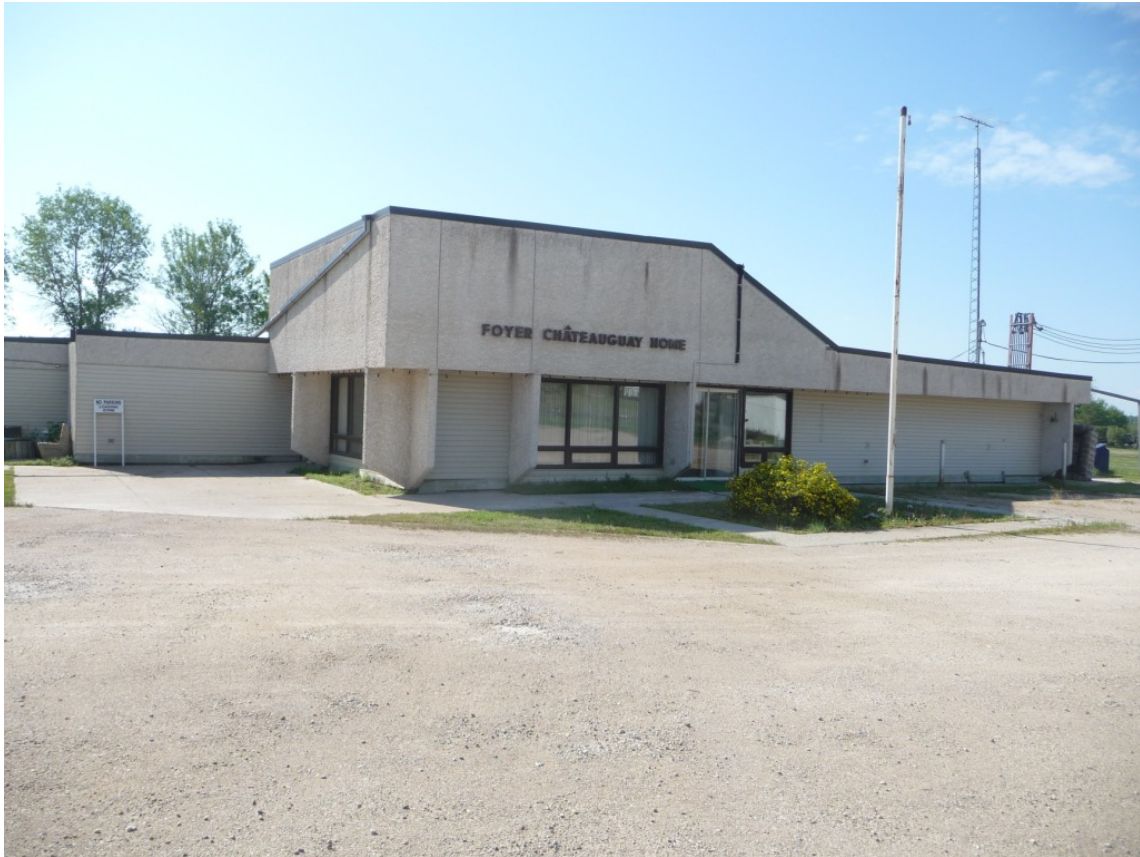
FIG. 1: BUILDING #1

This rural MURB was an unoccupied, 39-year old, single-storey building with a large central common area and 15 individual suites (each with two doors - one to the common area and one to the outdoors).

Buildings #1 and #2 (see Figure 1 and Figure 2, below) were both unoccupied MURB's which were used to measure the impact of interior suite door position (open or closed) on the overall airtightness of the structures. They were also used to determine if reliable results from an airtightness test could be generated if a small number of suite windows were left open during the test. While this is a departure from established testing procedures, there was the possibility that reasonable results could still be obtained since the flow resistance between a suite and the rest of the building would mitigate (somewhat) the influence of the open window. The information gleaned from these two buildings was used to establish a modified airtightness testing protocol which could be used on occupied MURB's.

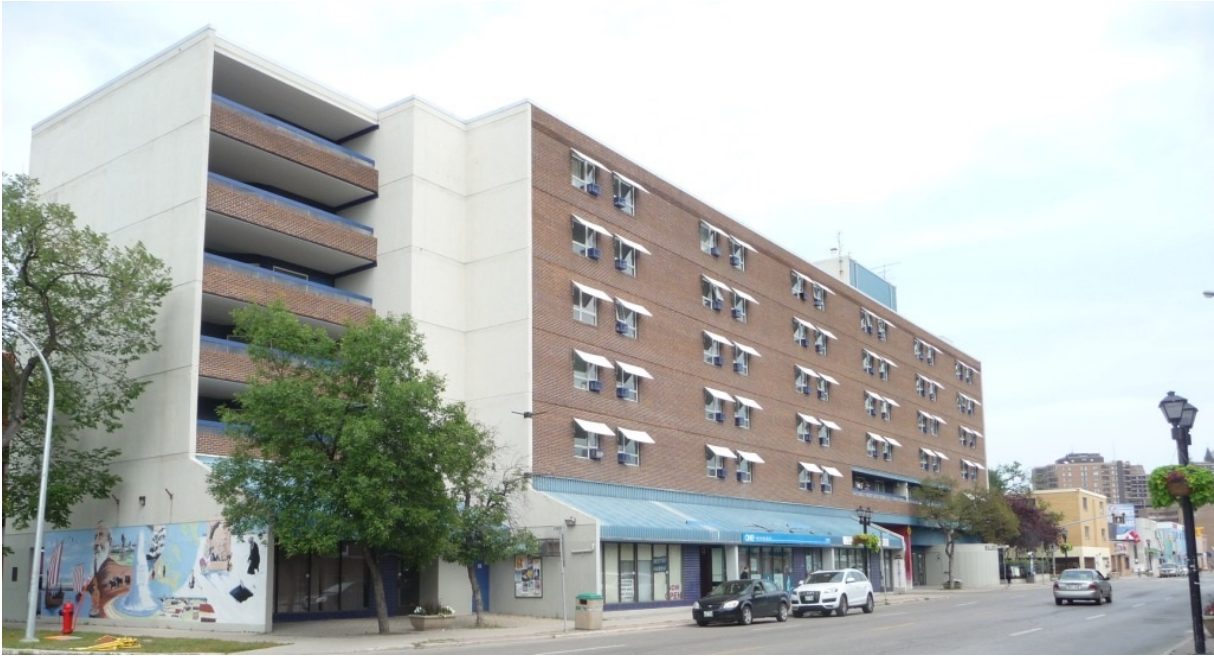
FIG 2: BUILDING #2

This Winnipeg MURB was a 35-year old, six-storey structure which had just begun major renovations to modernize the suites. It contained 124 suites and a common area. At the time of the testing, the building was occupied by a single tenant and a small number of workmen.

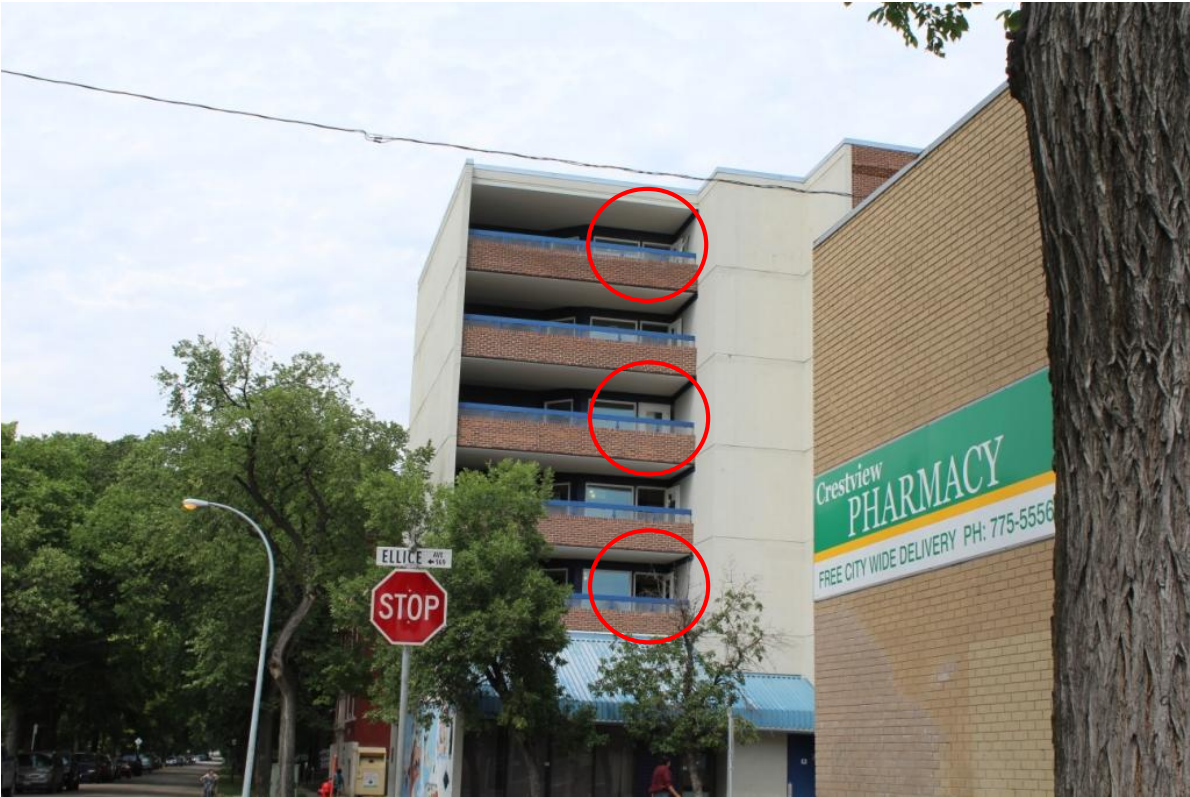
FIG 3: BUILDING #2 Location of blower doors in the balconies

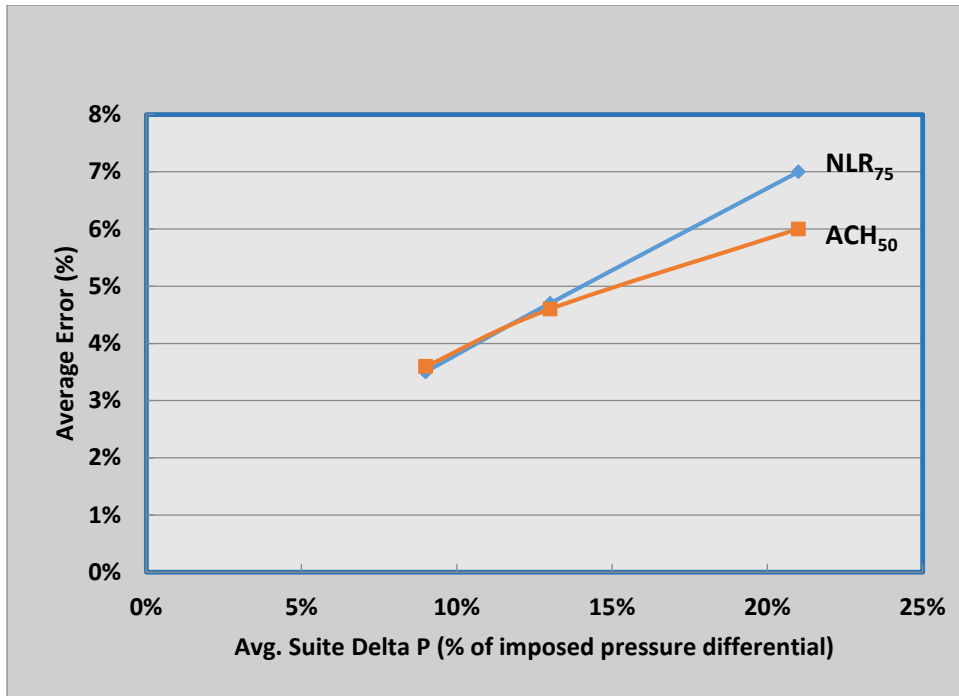
where $K2 = 1 + [0.1964 (\Delta P/75) + 0.0192]$

and ΔP = average pressure differential across the suite doors (in Pascals)

Fig. 4. Airtightness Results Error vs. Suite Delta P

Example: To illustrate how the correction would be applied, consider the results from Building #1. The measured NLR₇₅ with the suite doors closed was 1.28 l/s•m² (see Table 1 above, Test 1-5). The average pressure differential measured across the suite doors when the building was depressurized to 75 Pa, was 16 Pa. Using the regression equation described above, calculating the true NLR₇₅, i.e. the result which would be attained had the test been conducted with the interior doors open, would be done by the following:

This building displayed comparatively high pressure drops across the suite doors. As a result, the correction factors ranged from 11.6% to 15.2% - which required significant extrapolation beyond the range shown in Fig. 4.

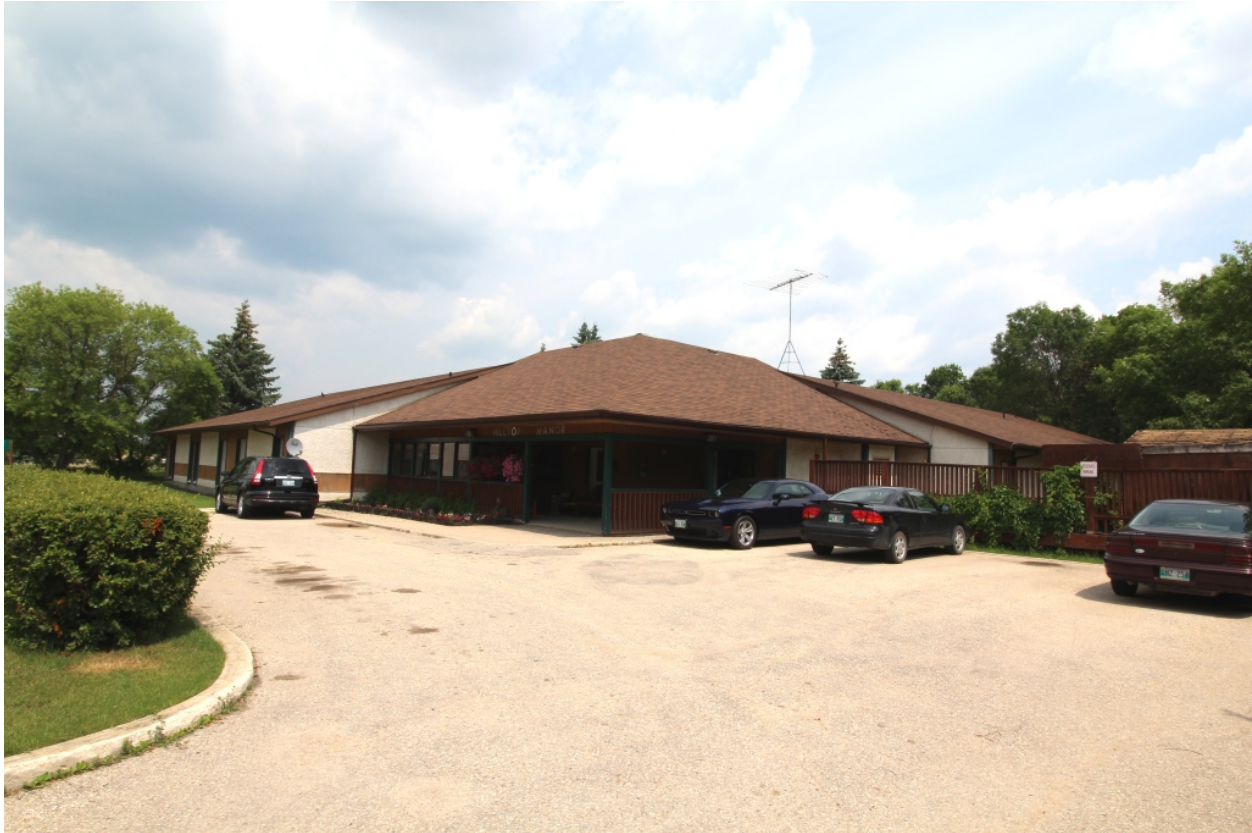
Fig 5: Building #3

Description: Single-storey, 12-unit MURB.

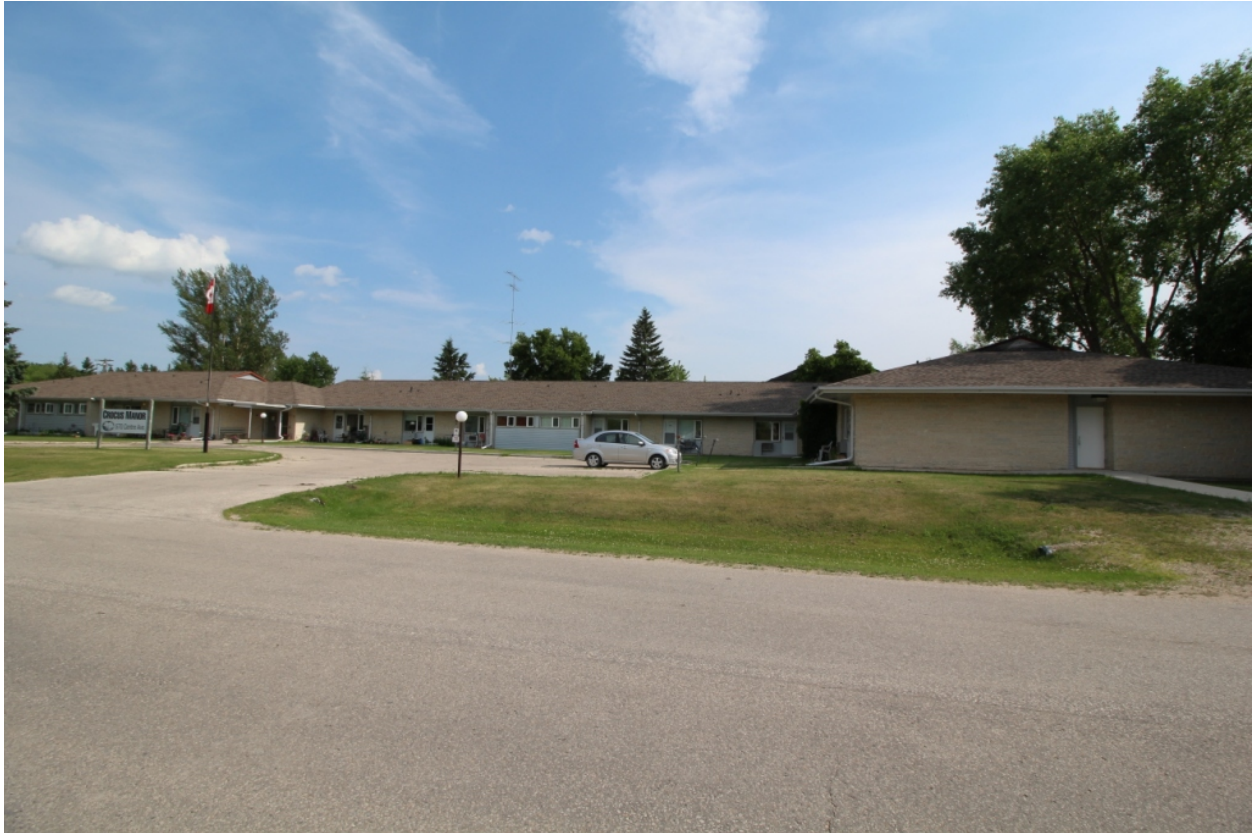
Fig. 6: Building #4

Description: Single-storey, 28-unit MURB.

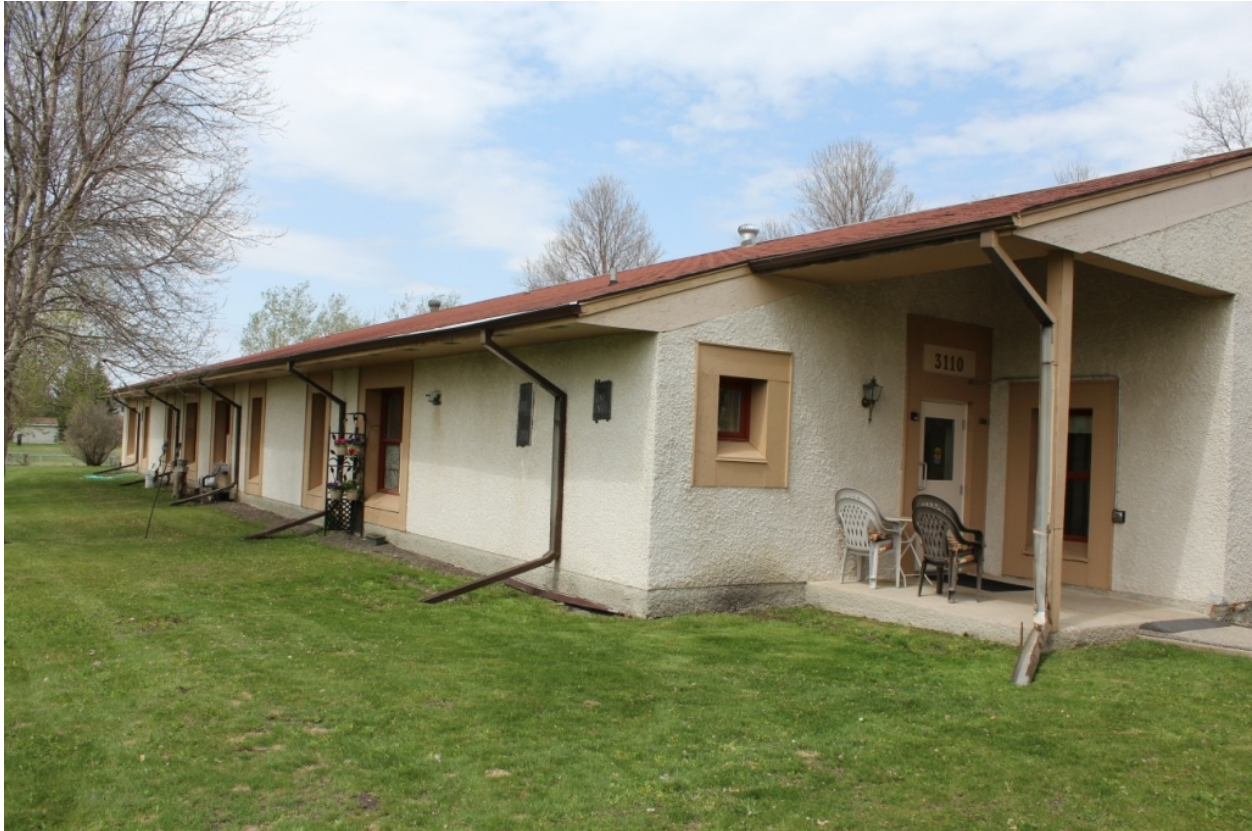
Fig. 7: Building #5

Description: Single-storey, 8-unit MURB.

Building #5 was added at the request of Manitoba Housing due to its high heating costs. During the pre-test review, the outdoor temperature was -2 °C yet four of the apartments had their windows completely open. This is believed to be due to poor ventilation provided by the central air make-up system which supplies air to the suites via the corridor. The door undercuts and through-wall corridor transfer vents were inadequate, requiring the tenants to keep their windows open and the baseboard heaters on.

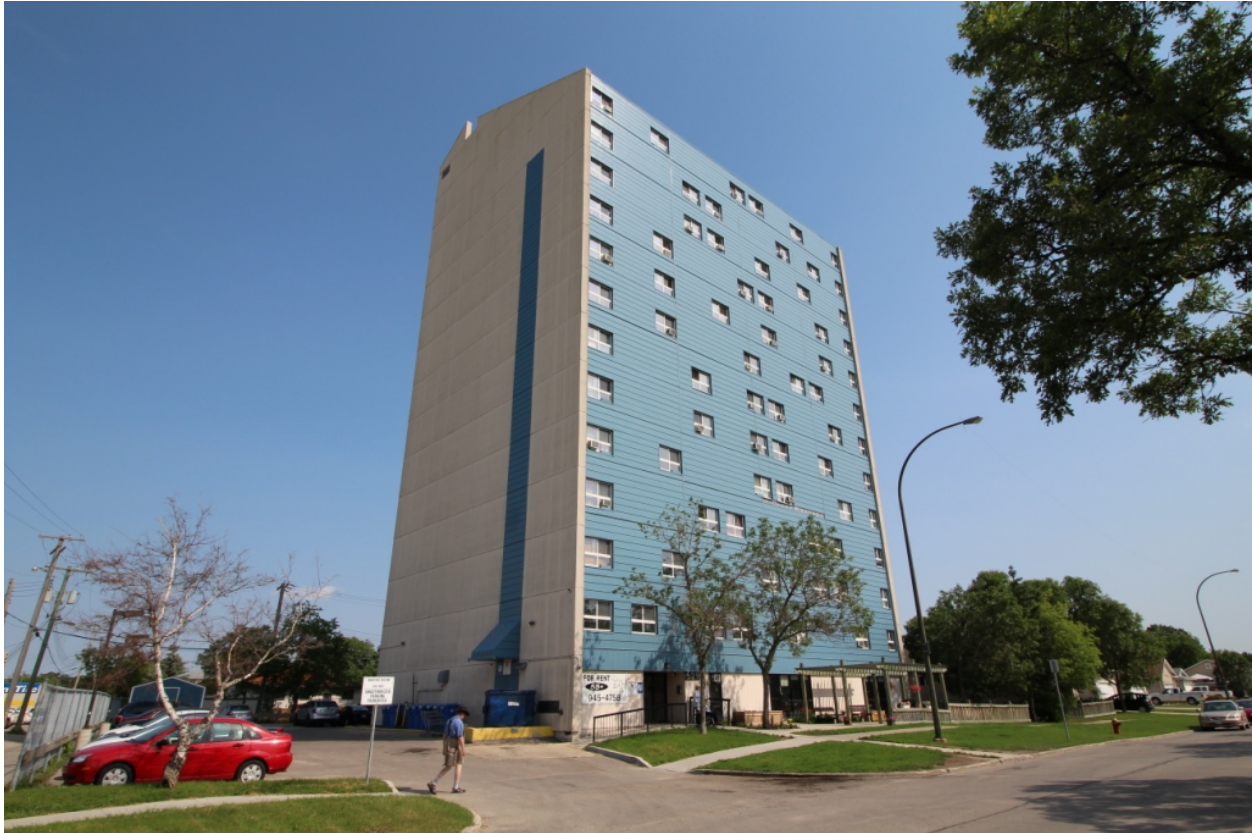
Fig. 8: Building #6

Description: 13-storey, 107-unit MURB.

During the pressurization test, all windows were visually checked from the outside and appeared to be fully closed and locked. However as the test pressure was increased, many of them began to open - either uniformly along the hinge axis or at a single corner. Typical crack size was about 13 mm ($\frac{1}{2}$ ") at 75 Pa. Some tenants had not closed and locked their windows, some were not physically capable of closing them while other window units had broken hardware and were no longer capable of being locked at both corners. Windows left open by the tenants were closed and locked. Faulty windows were left as-is (this was considered the normal operating condition of the building) and the test re-run. No other building related issues were encountered.

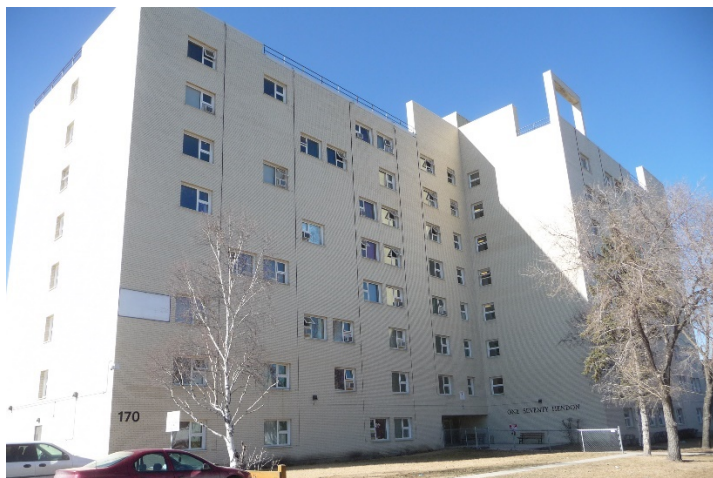
Mid and High-Rise Apartments

A tall structure that typically has at least six floors, common entrances, areas and corridors. These buildings have centralized HVAC systems (with many intentional openings) which have to be carefully studied to prepare them for the test.

An airtightness test on a high-rise apartment requires care to ensure the building is properly prepared (verifying and correctly sealing the building's intentional openings) and that proper control is exercised over the mechanical system. Since it is a multi-storey structure, the testers must verify that the desired pressure differential is attained across the building envelope. The equipment setup should allow for at least one operable exterior access to the corridor, preferably the entrance closest to the elevator(s). If possible, the test equipment can be set up in the emergency exits to minimize disruption and keep the main entrances operational.

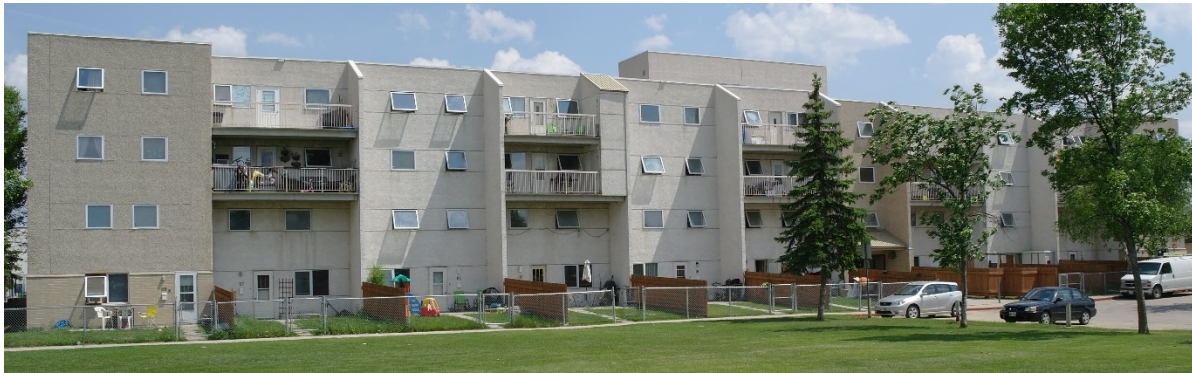
Low-Rise Apartments

This type of MURB typically has two to four floors, and is usually provided with elevator service. They usually have common entrances, although individual suite doors which open to the outdoors are frequently included. The HVAC systems can be either fully centralized or a mix of centralized and suite-located.

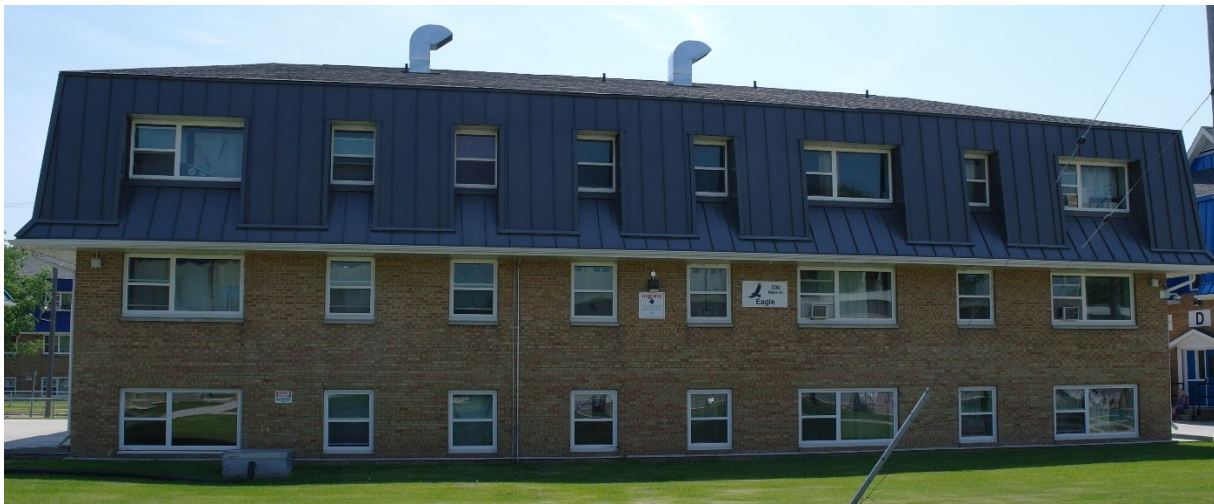
Low-Rise, Walk-up Apartments

A building that is typically between two and four floors without elevator service. They usually have common entrances, corridors and centralized HVAC systems.

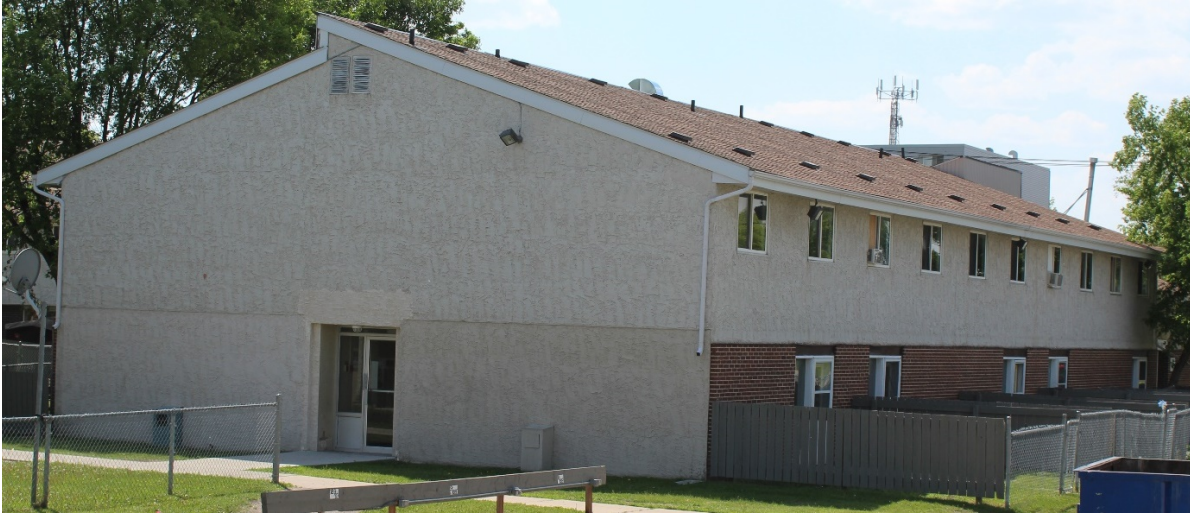
Maisonette

A two-story building with the apartments sharing a common corridor and, in some cases, have individual exterior entrances. The HVAC systems can be either fully centralized or a mix of centralized and suite-located

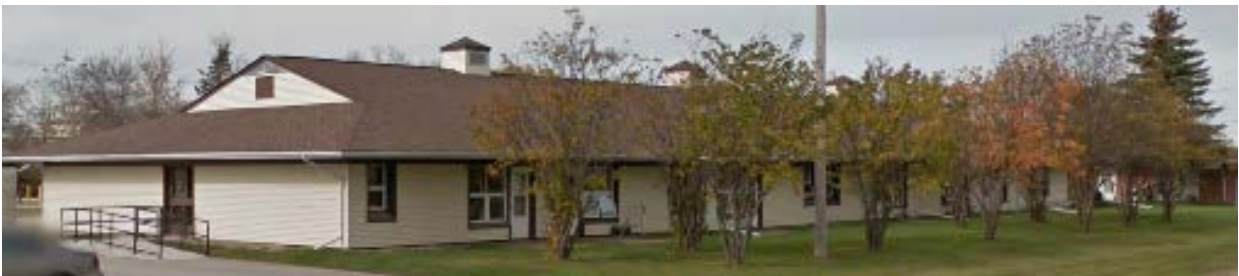
Motel Style

A single-story building with the apartments sharing a common corridor with individual exterior entrances. These buildings have a main entrance/vestibule serving the corridor and common area.

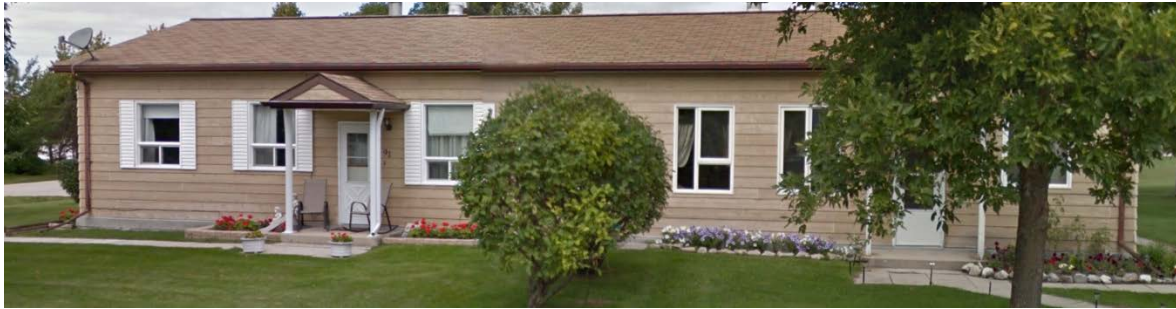
Duplex

Basically, this is a house divided into two apartments, each with separate entrances. Each unit typically has its own HVAC system.

Since there is no common corridor, this type of MURB cannot be tested with the new protocol.

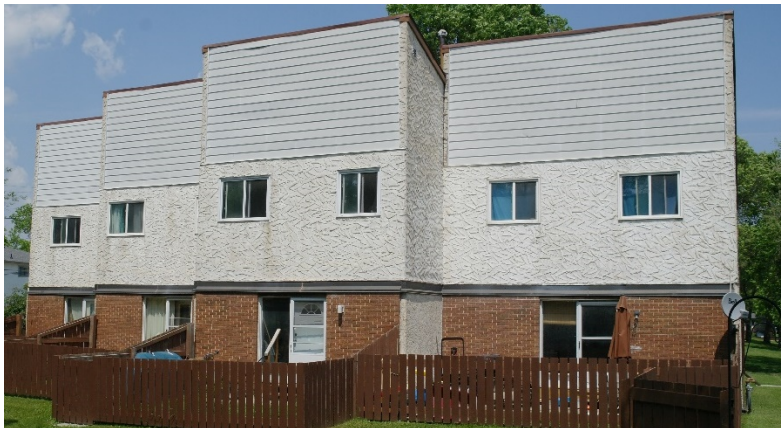
Fourplex

Basically, this is a house divided into four apartments, each with separate entrances. Each unit typically has its own HVAC system.

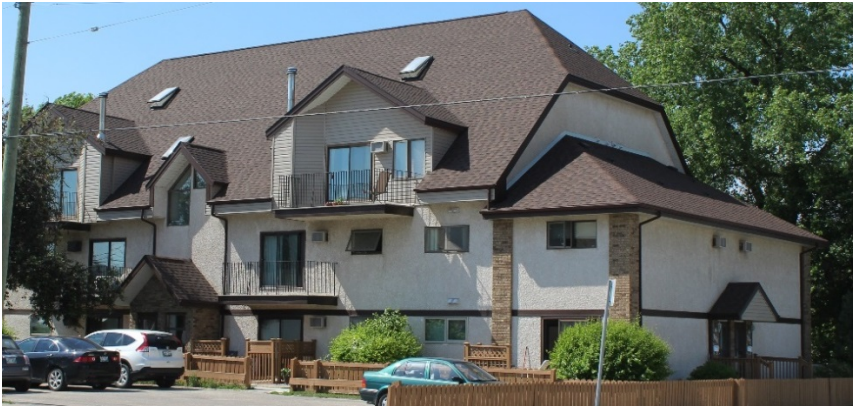
Stacked townhouse

A building with the majority of apartments accessed through a common corridor. The remaining apartments have separate entrances and do not have apartment access from the corridor.

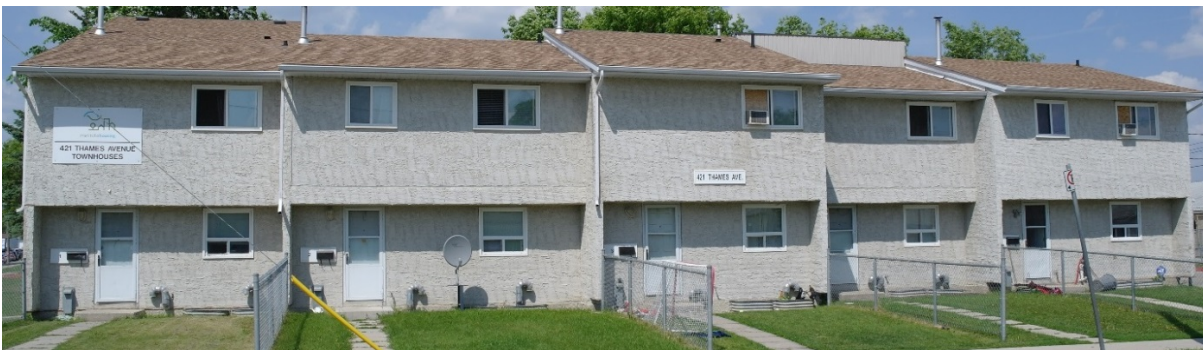
Townhouse

A building with adjacent apartments with separate exterior entrances.
